**Key words:** potable water, stratification, chloramine, nitrification

**Reservoir or Lake Use:** This is an enclosed water storage reservoir for potable chloraminated water.

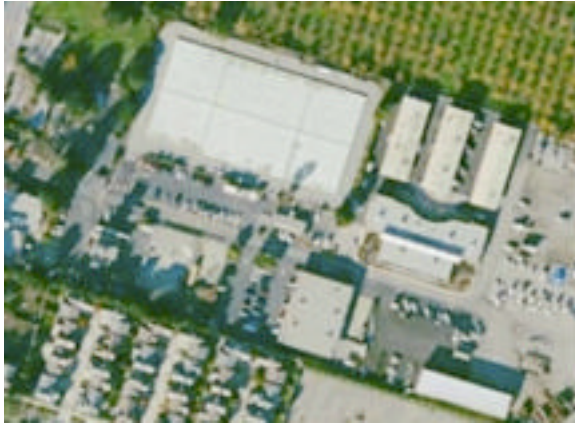
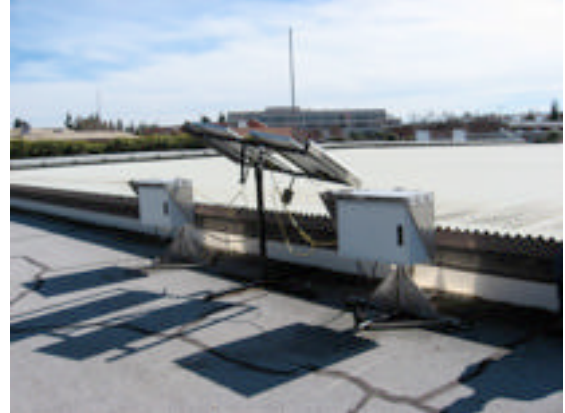
**Photo:** First photo is an aerial view of the reservoir with concrete cover; second photo shows electronic control boxes and solar panels mounted on the top of the tank.

**SolarBee Installation:** Date: Jan 2003. Installed one SB10000F with a 24-hour electric kit and roof-mounted solar rack, with intake hose set at 15.5 ft. The machine was installed through a 9.5' X 9.5' hatch in the roof, assembled on the sidewall slope within the tank, and anchored to the support columns in the tank. In June 2005, the single SB10000F unit was changed out to two (2) SB1250v12 units, one deployed on either side of the baffle wall.
